United Nations
Educational, Scientific and
Cultural Organization

وزارة الثقافة
Ministère de la Culture
Direction Générale des Antiquités

Emergency Safeguarding of the World Heritage Site of Byblos

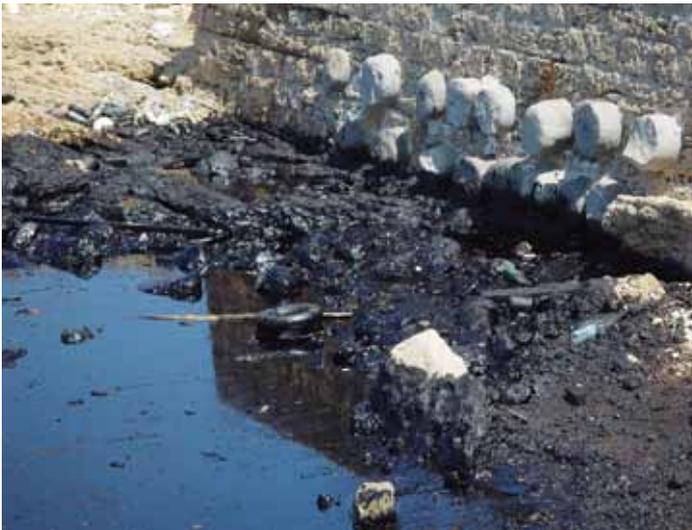
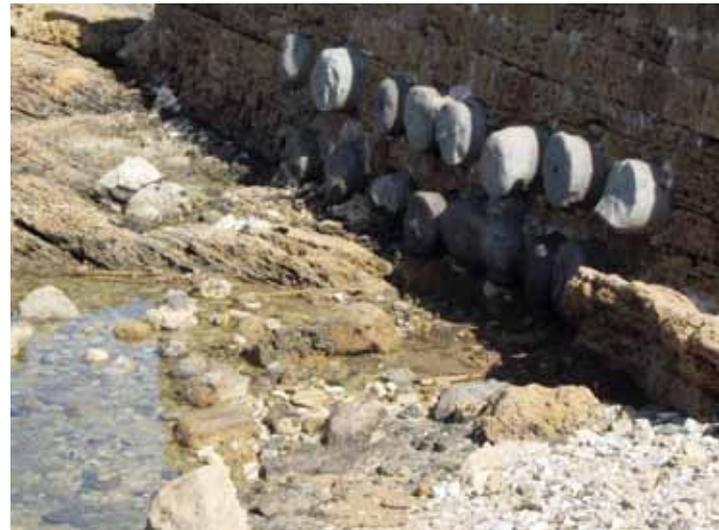
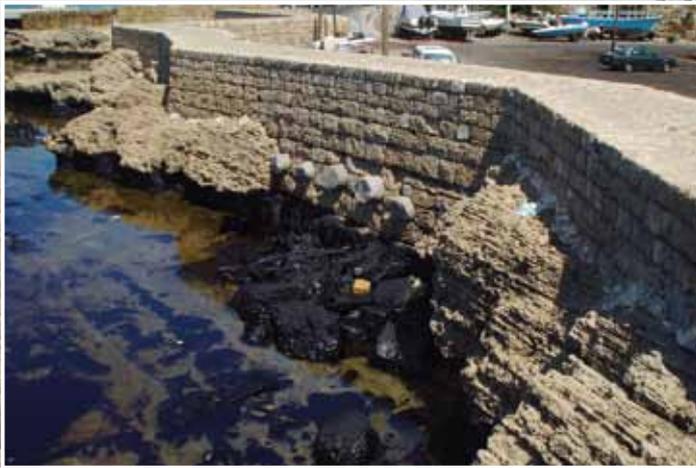
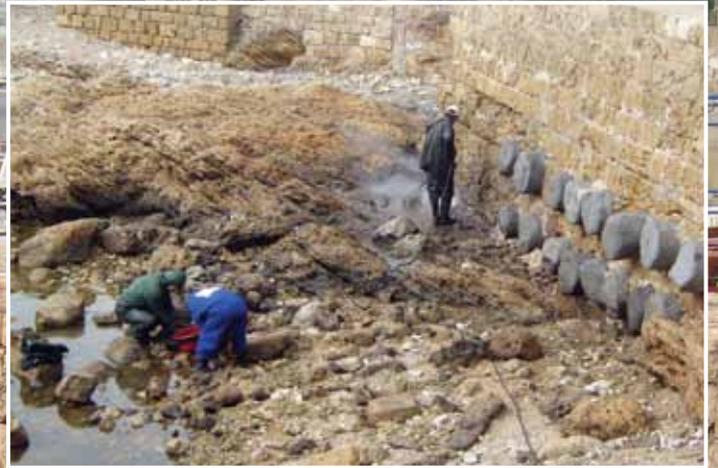
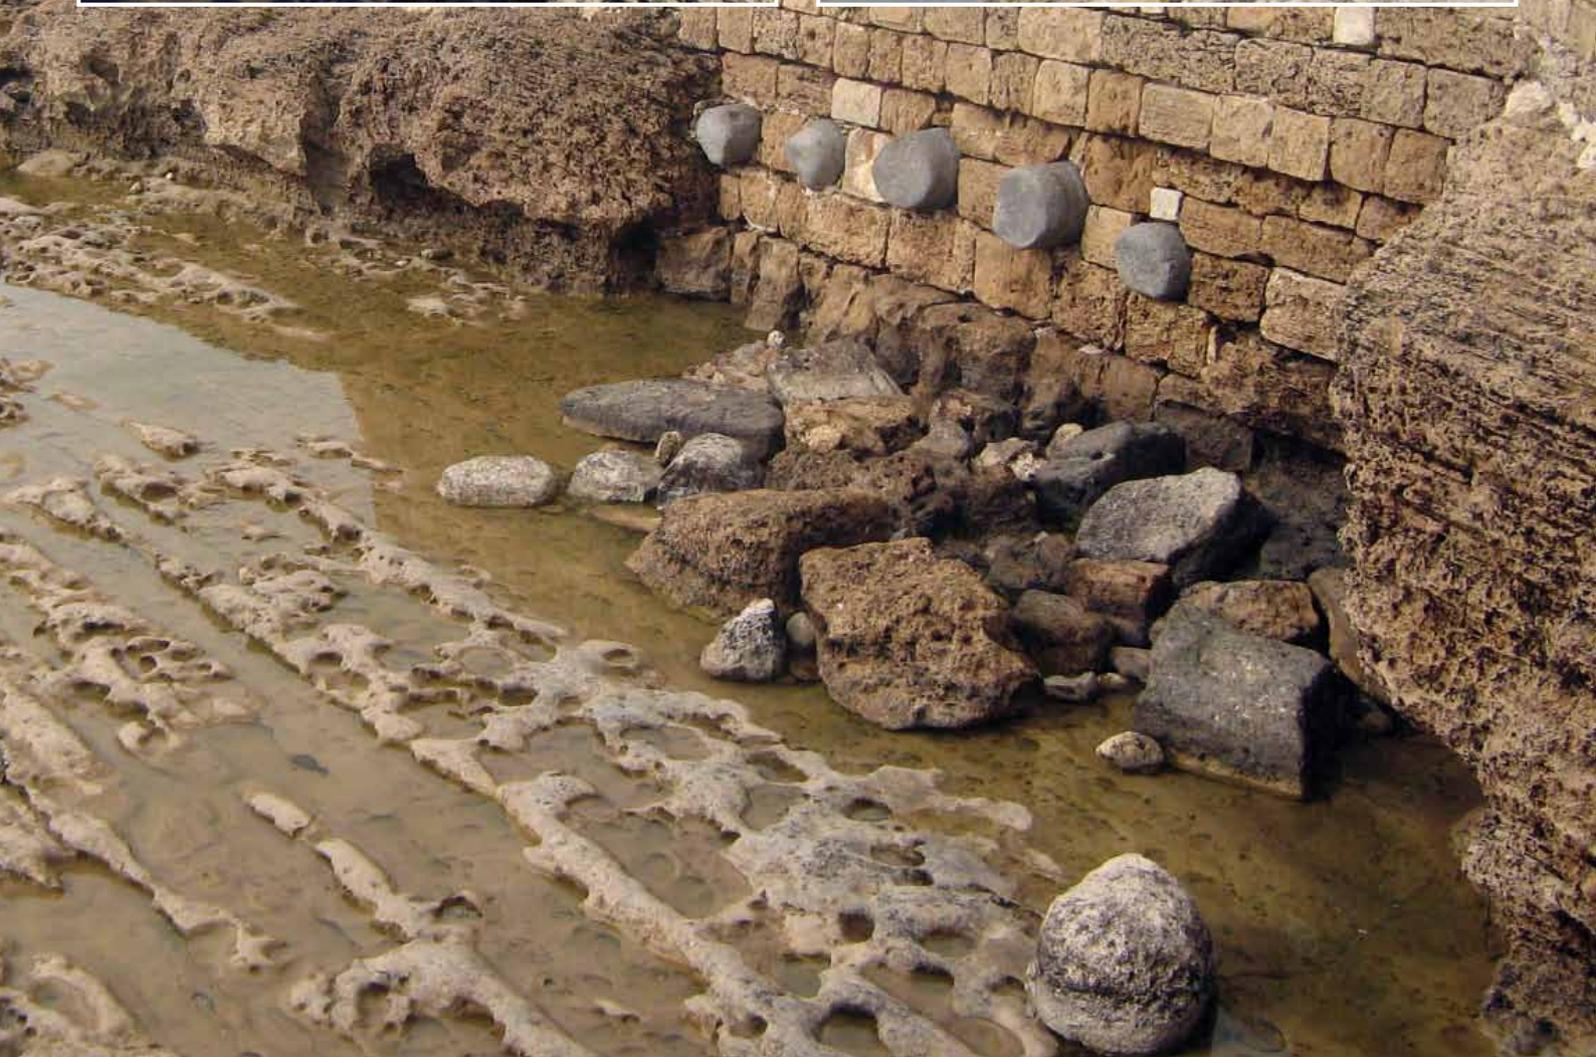
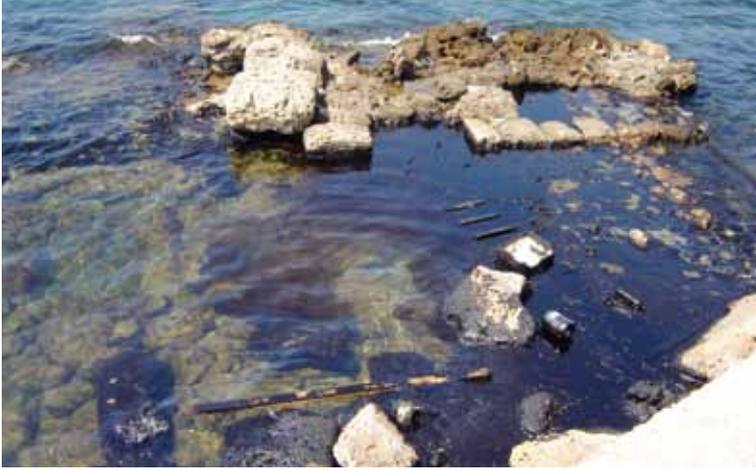
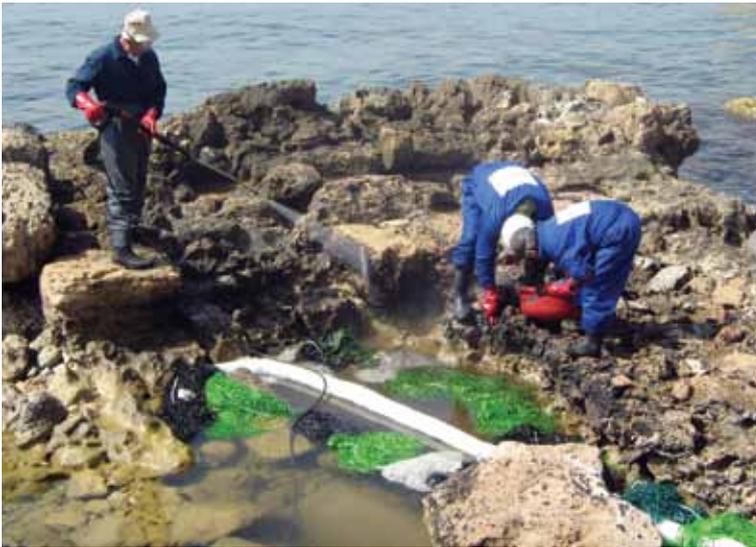
Collection of all polluted waste and debris was manually executed, placed in heavy duty bags and transported to the disposal area. Oil absorbent booms, pads and snares were used at all times in a fence-like manner in order to retain the oil and prevent it from seeping throughout the

sea water. The clean-up operation also used nylon bristle brushes and low hot water pressure jet washing machines in order to minimize the damages on the archaeological structures. These pressure jets operated using fresh water supply free from any solvent or chemical material. The water pressure ranged between 75 bars and 150 bars.

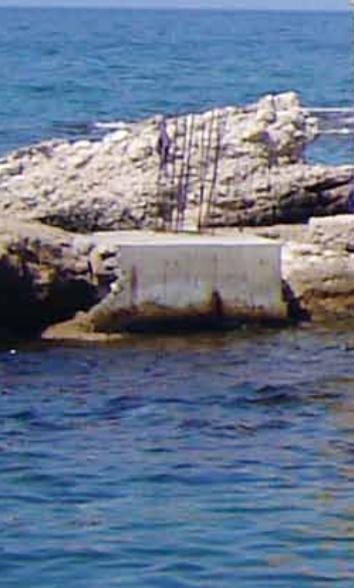
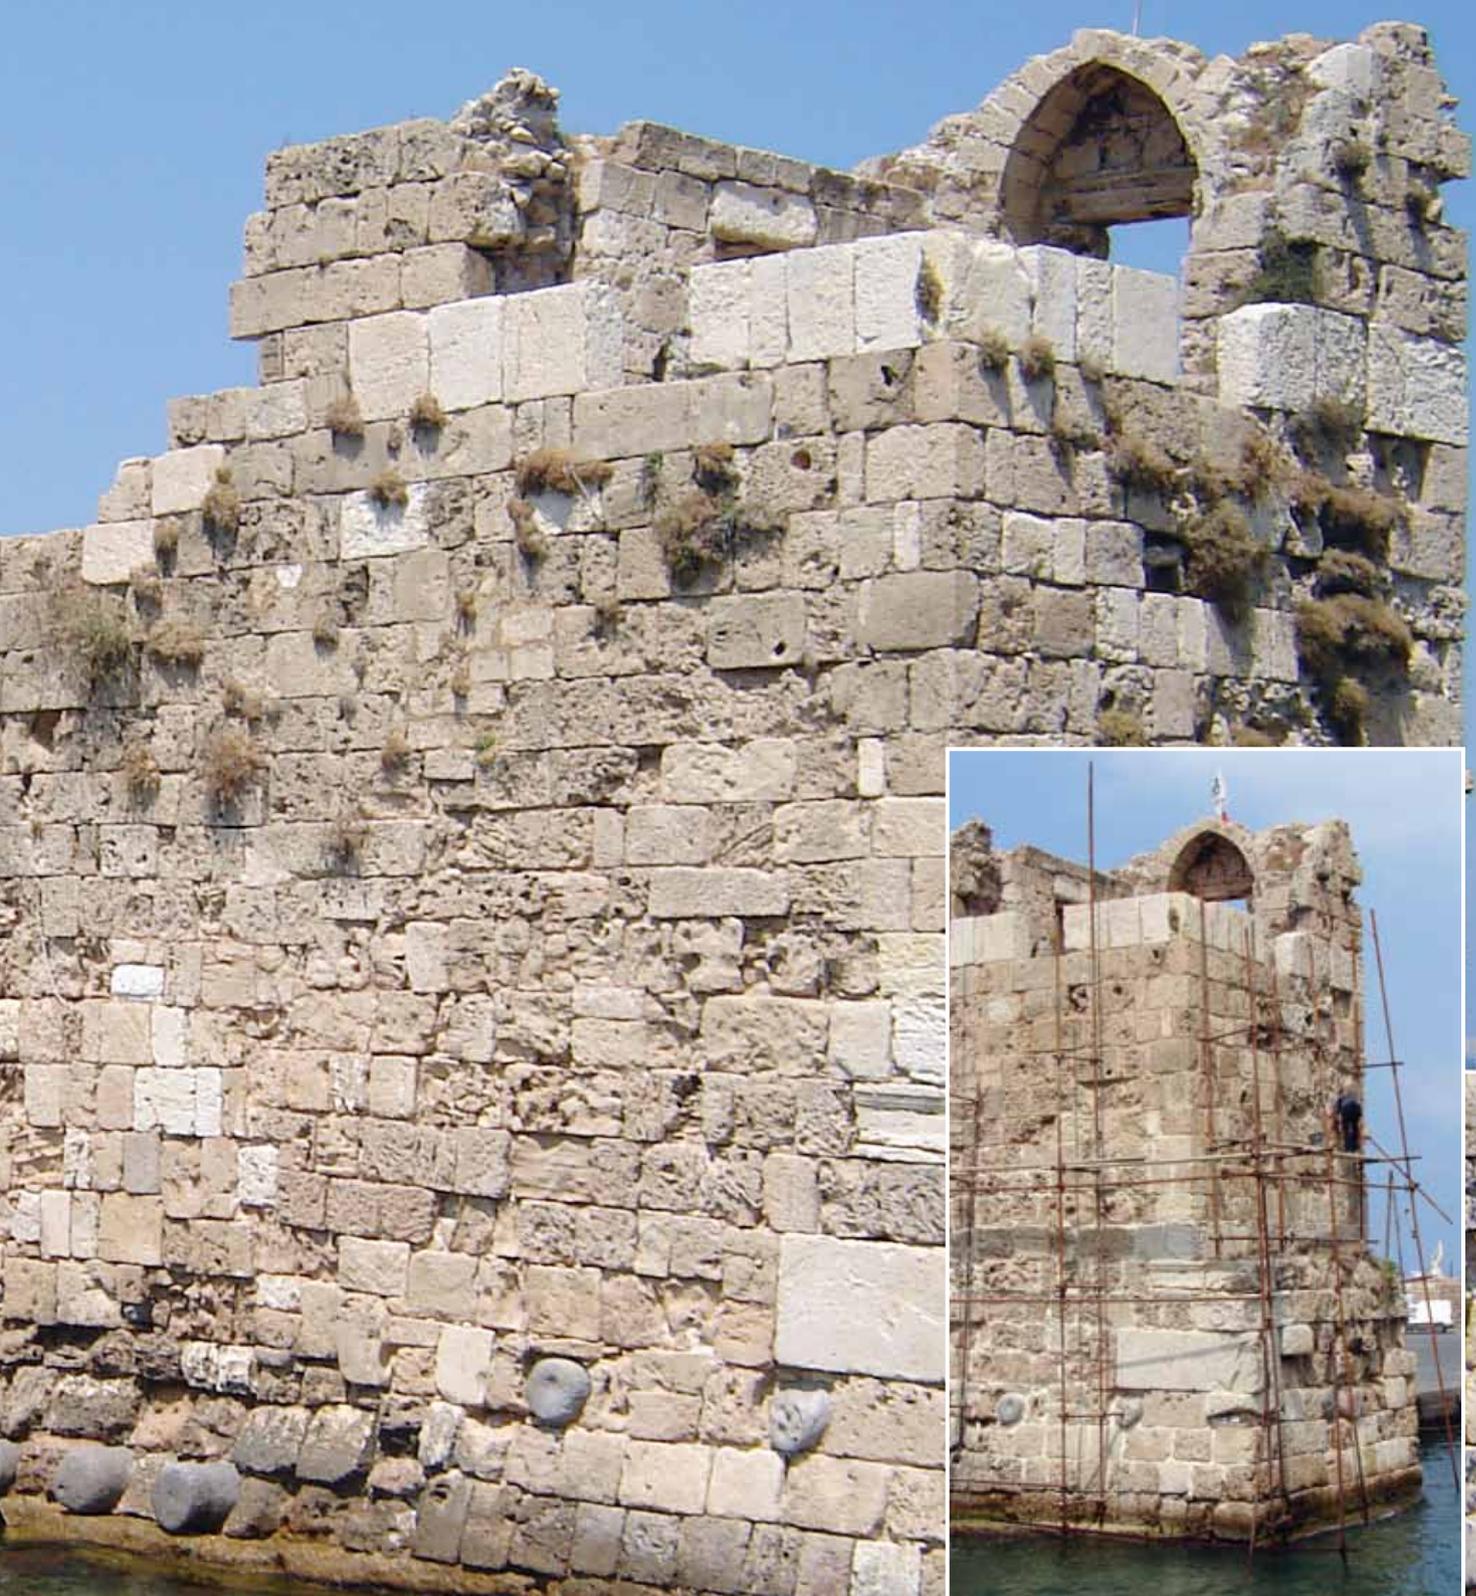
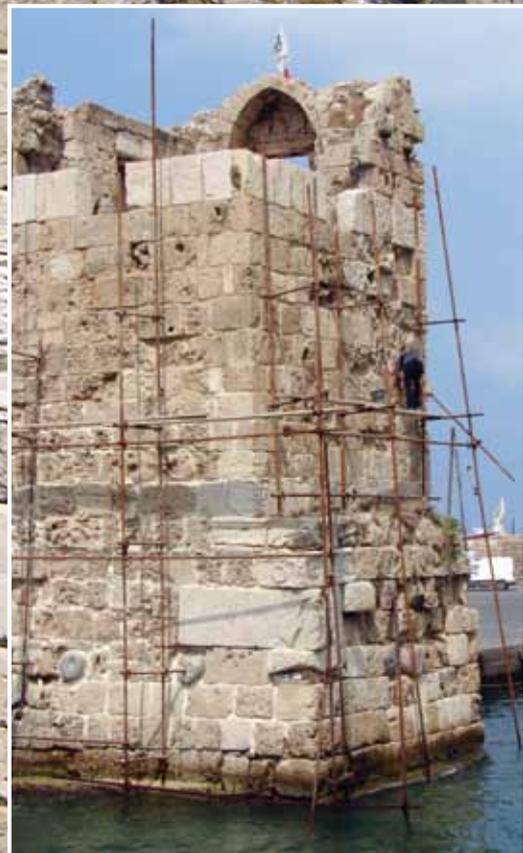
The northern Medieval tower presented critical under water structural damages mainly at the southeastern corner foundation.

An underwater cavity measuring 4m length x 2m height x 3m depth was located at its foundation level. The intervention projected to rebuild the lost parts associated with the two walls and refill the void with special concrete for underwater casting, allowing an expansion of the construction's load towards the foundation thus reassuring its structural stability. Stone types similar to those of this archaeological structure were used to carry out the conservation works.

Undergrowth from vegetation roots developing deep between the stones destroyed the binder favoring infiltration from waterways into the heart of the structure. Therefore, the wild vegetation was carefully cut out and a special anti-weed growth product injected. The deteriorated stones were then replaced by similar ones. Furthermore, a general restructuring operation was performed to consolidate the edifice, prevent further vegetation growth between the stones and protect the masonry from any rainwater erosion effect. Traditional lime mortar was used as a soft binder to avoid future damages to the structure. This intervention assured the stability of this unique existing Medieval tower at the ancient port of Byblos and preserved its outstanding value.

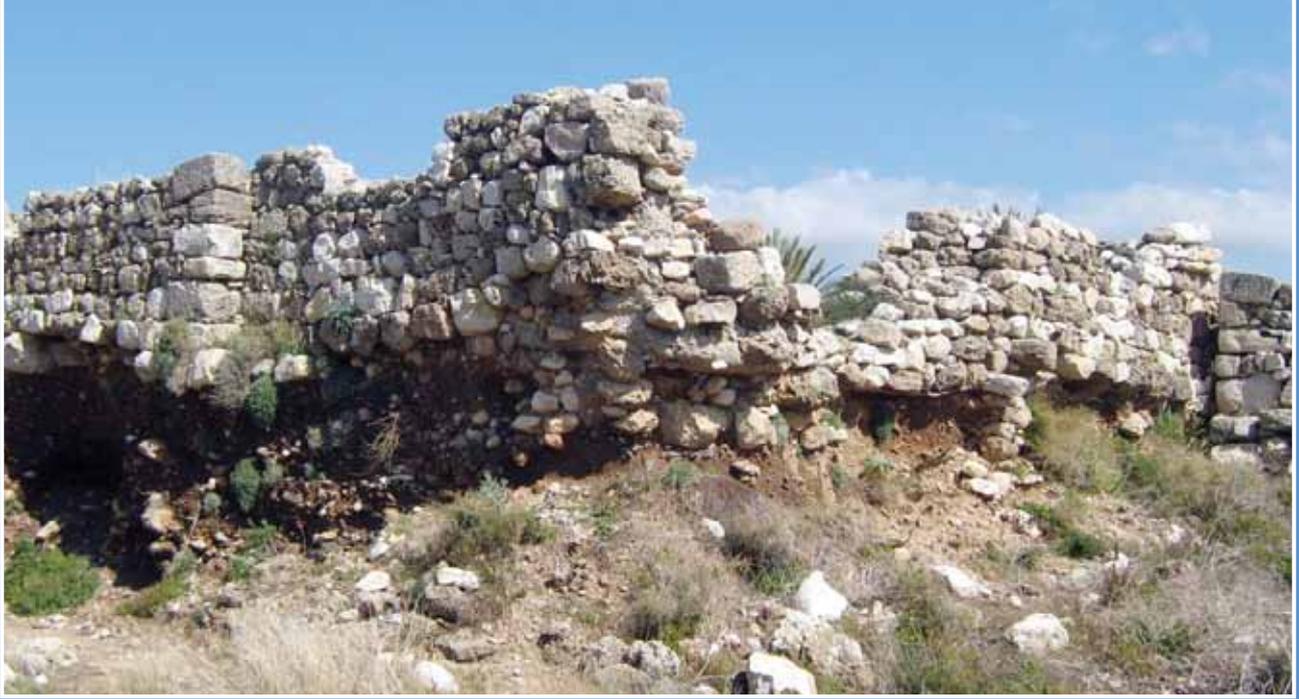
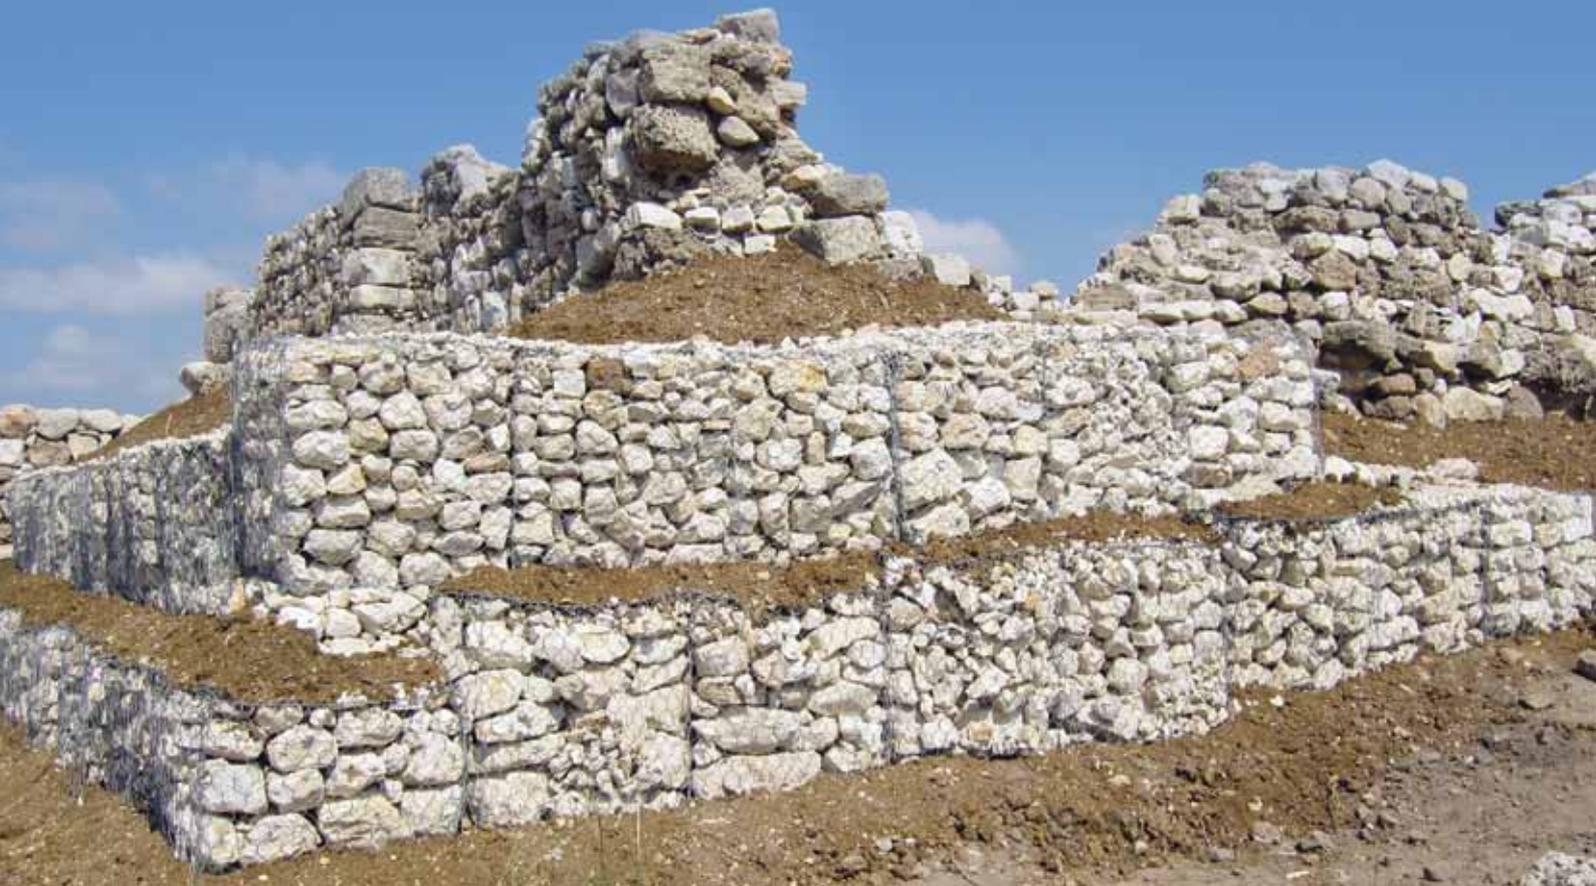
- 1. The vertical erosion area under the temple structure was brought under control by backfilling earth all around it to protect its foundation.*

A geotextile separation layer was spread between the archaeological soil and the new backfill material. A backfill gravel "tout-venant" was applied all around the temple, extending to the first foundation level and covering all vertical denuded sections.

"Gabion" cubes were installed in single, double or even three rows to limit and retain the gravel backfill. In addition, a 10 cm layer of earth was spread on the top of the backfilling material and the Gabion area.
